Manhole Inspection Summary

Manhole # S37W1_025MH

Location Address: **103 E Patapsco Ave**

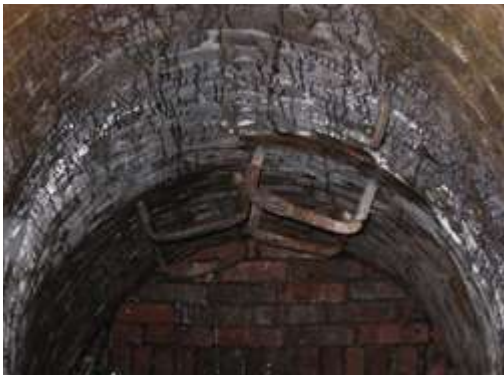
Steps

Count: **6** Missing: **2** ☒ **Corroded**

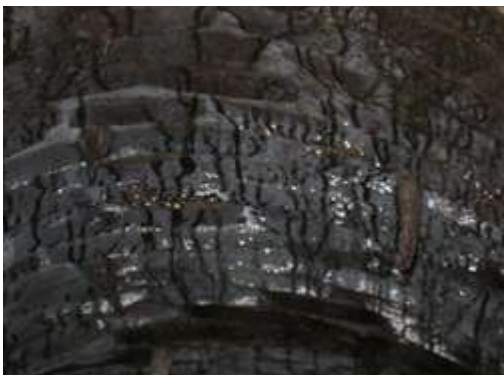
Defect 2

Missing steps/ corroded steps

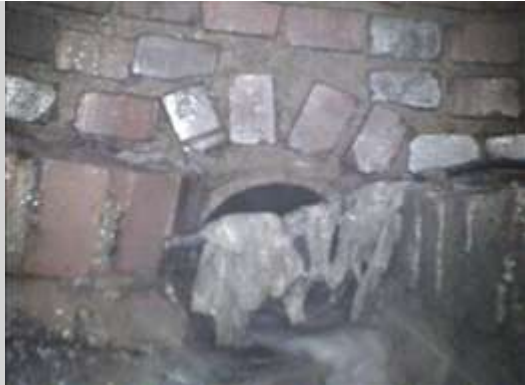
12 O'Clock Outflow

Large piece of debris obstructing view
